## Comprehensive Storm Sewer Map

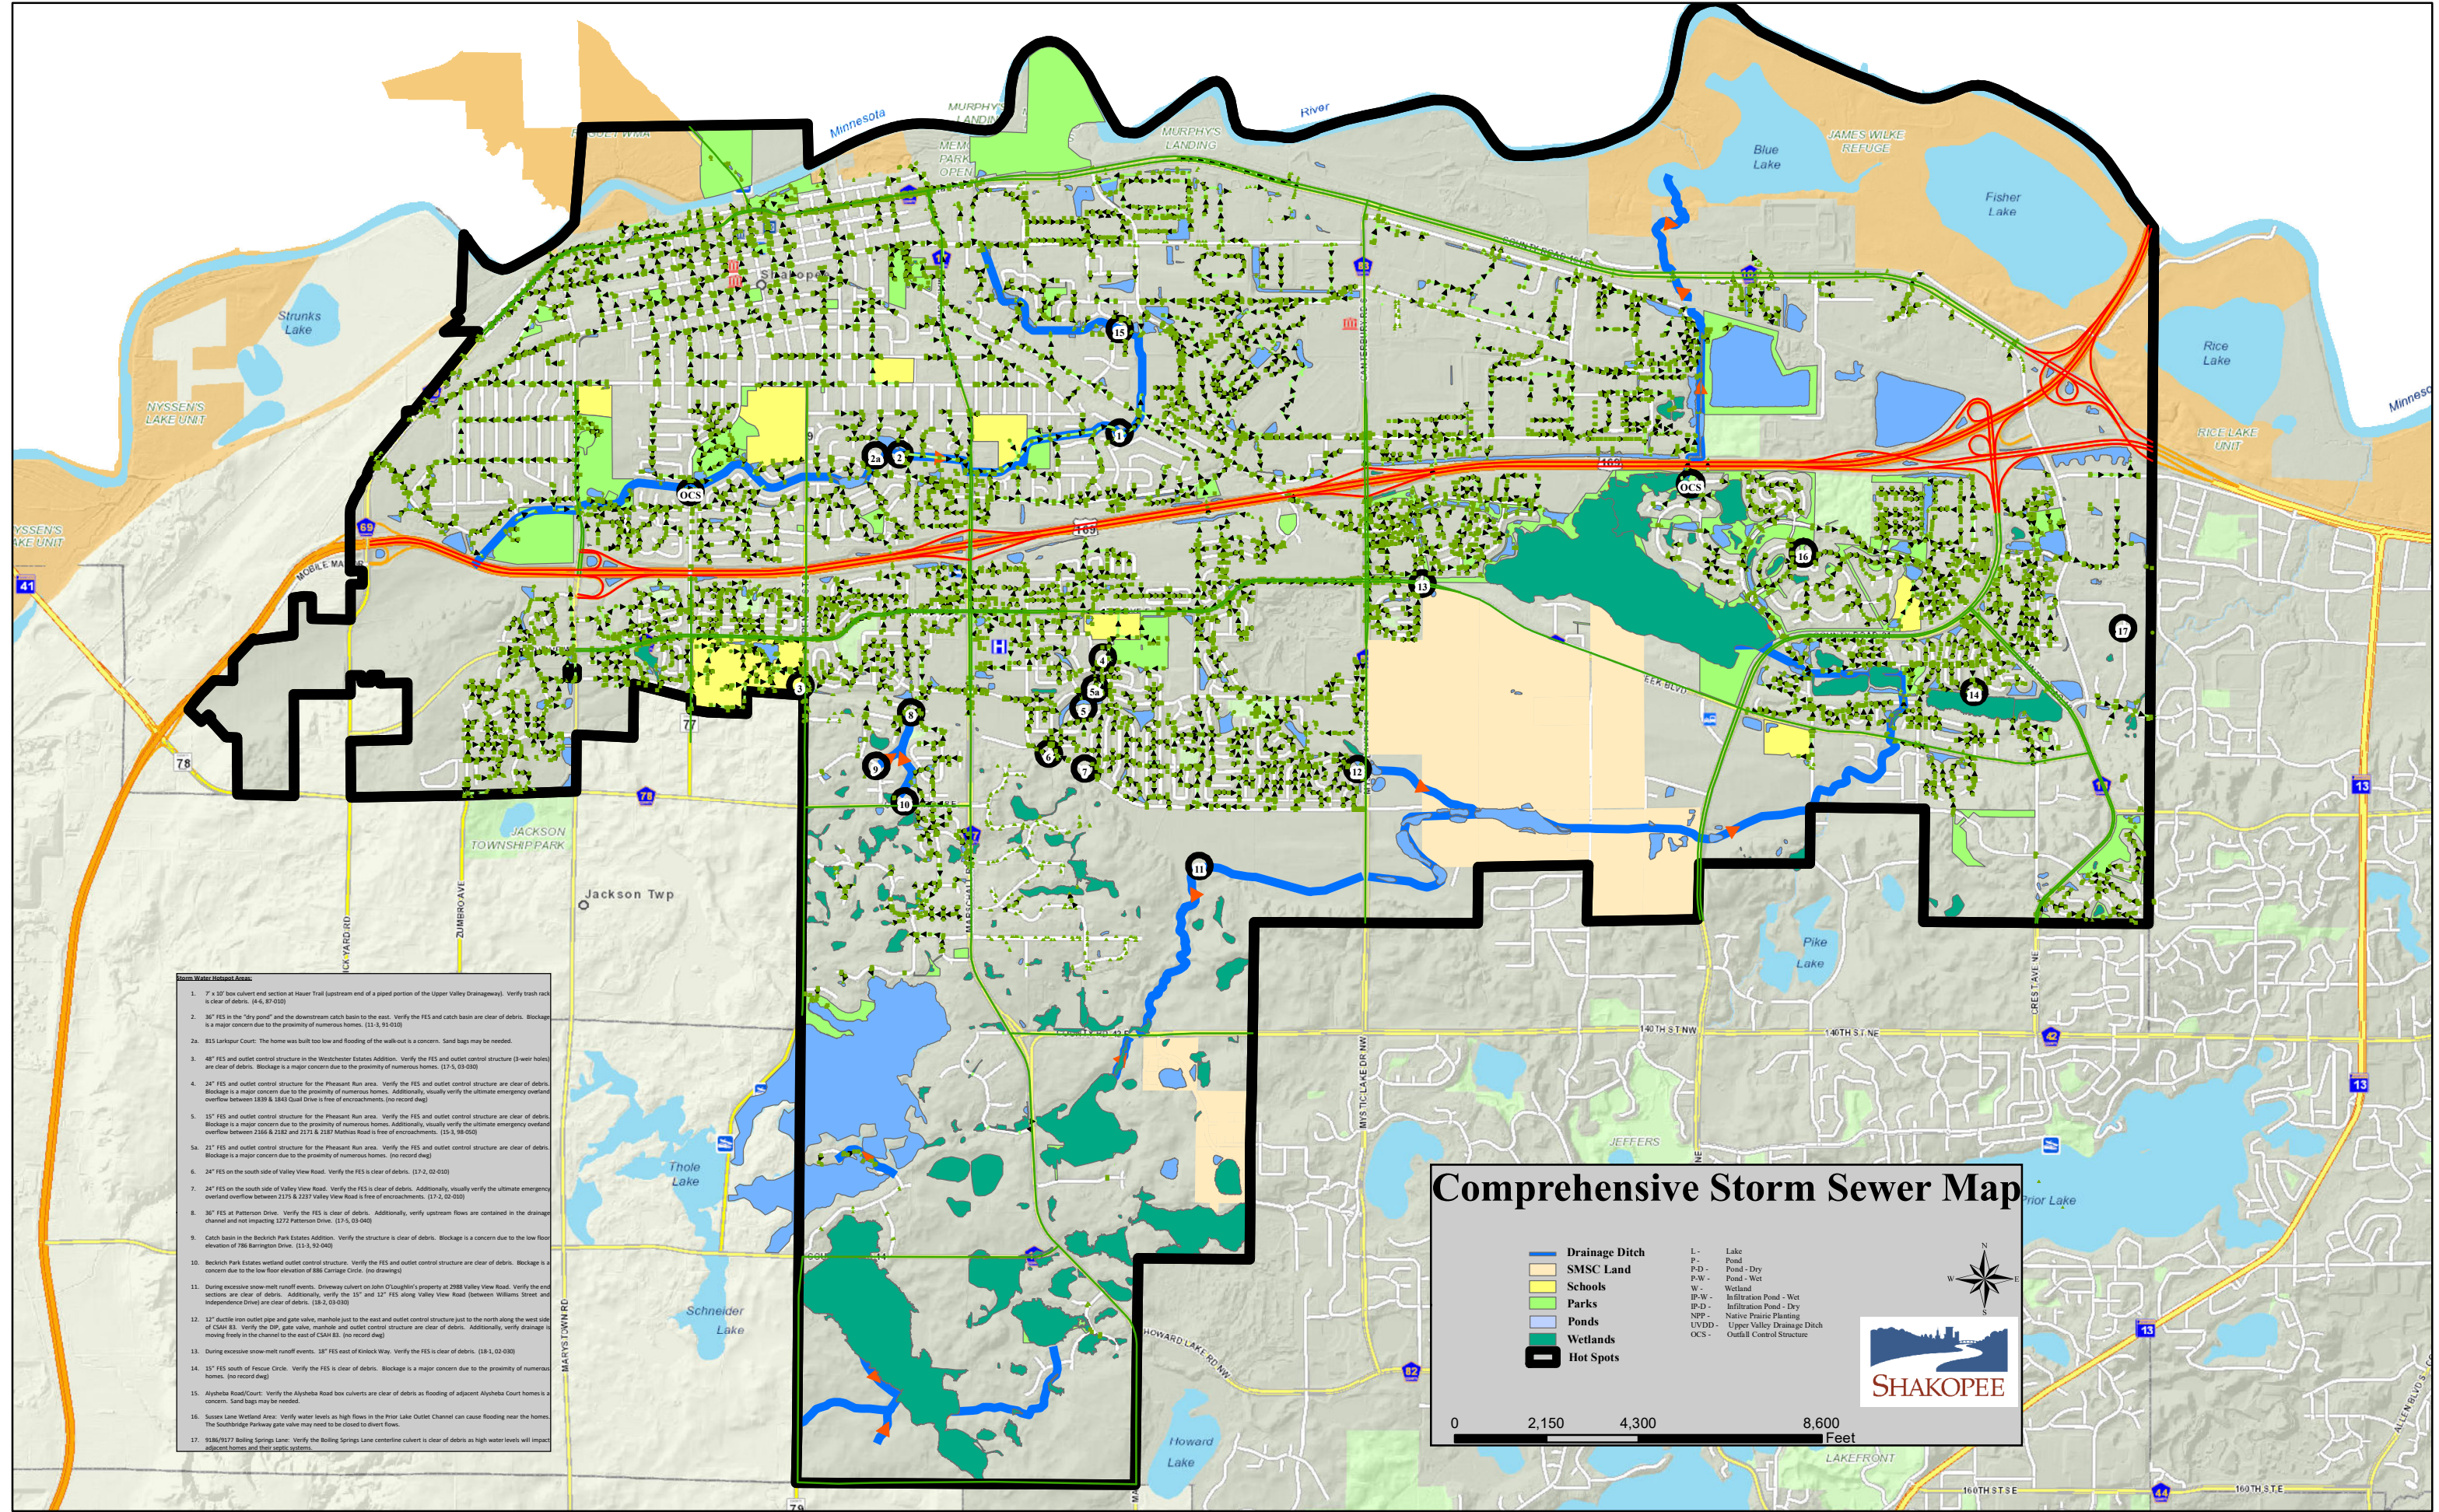
- Storm Water Hotspot Areas:**
- 7" x 10" box culvert end section at Haver Trail (upstream end of a piped portion of the Upper Valley Drainageway). Verify trash rack is clear of debris. (4-6, 87-030)

- 36" FES in the "dry pond" and the downstream catch basin to the east. Verify the FES and catch basin are clear of debris. Blockage is a major concern due to the proximity of numerous homes. (12-3, 93-038)

- 815 Larkspur Court: The home was built too low and flooding of the walk-out is a concern. Sand bags may be needed.
  - 48" FES and outlet control structure in the Westchester Estates Addition. Verify the FES and outlet control structure (3-weir holes) are clear of debris. Blockage is a major concern due to the proximity of numerous homes. (17-5, 03-030)

- 24" FES and outlet control structure for the Pheasant Run area. Verify the FES and outlet control structure are clear of debris. Blockage is a major concern due to the proximity of numerous homes. Additionally, visually verify the ultimate emergency overflow between 1839 & 1843 Quail Drive is free of encroachments. (no record dwg)

- 15" FES and outlet control structure for the Pheasant Run area. Verify the FES and outlet control structure are clear of debris. Blockage is a major concern due to the proximity of numerous homes. Additionally, visually verify the ultimate emergency overflow between 2166 & 2182 and 2171 & 2187 Mathias Road is free of encroachments. (15-3, 98-050)

- 21" FES and outlet control structure for the Pheasant Run area. Verify the FES and outlet control structure are clear of debris. Blockage is a major concern due to the proximity of numerous homes. (no record dwg)

- 24" FES on the south side of Valley View Road. Verify the FES is clear of debris. (17-2, 02-010)
  - 24" FES on the south side of Valley View Road. Verify the FES is clear of debris. Additionally, visually verify the ultimate emergency overflow between 2175 & 2231 Valley View Road is free of encroachments. (17-2, 02-010)

- Sageau Lane Wetland Area: Verify water levels as high flows in the Prior Lake Outlet Channel can cause flooding near the homes. The Southbridge Parkway gate valve may need to be closed to divert flows.
